NEW YORK STATE DEPARTMENT OF ENVIRONMENTAL CONSERVATION

January 9, 2024

Re: Skaneateles Lake Dam, State ID#: 073-0355

Large, Class C – High Hazard Skaneateles (V), Onondaga County

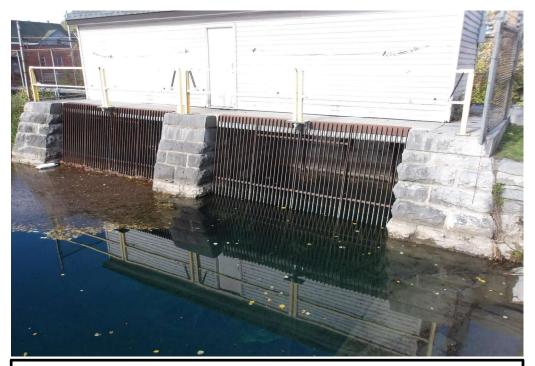
Photo 1 Dam ID# 073-0355 Skaneateles Lake Dam 10/23/2023 Upstream face of the dam.

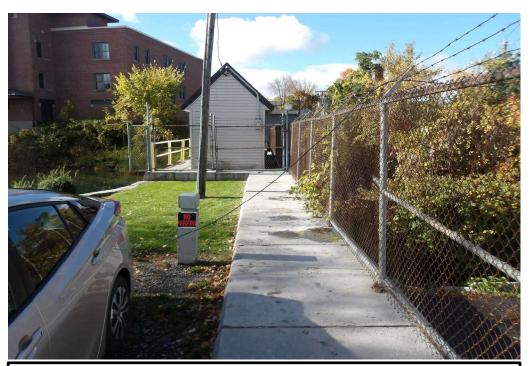
Photo 2 Dam ID# 073-0355 Skaneateles Lake Dam 10/23/2023 Dam crest looking left.

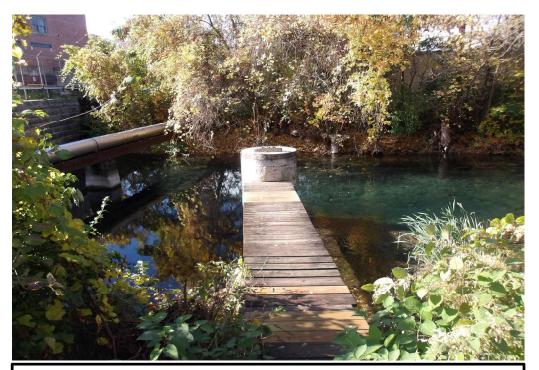
Photo 3 Dam ID# 073-0355 Skaneateles Lake Dam 10/23/2023 Downstream bridge.

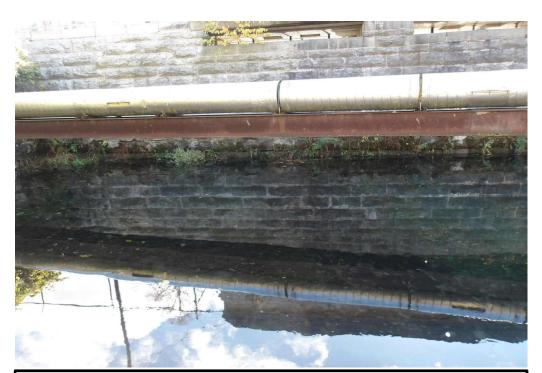
Photo 4 Dam ID# 073-0355 Skaneateles Lake Dam 10/23/2023 Right Downstream groin.

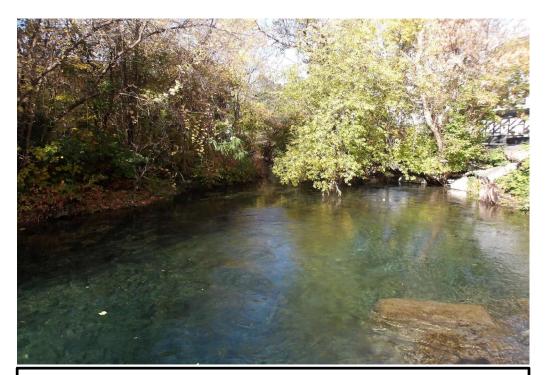
Photo 5 Dam ID# 073-0355 Skaneateles Lake Dam 10/23/2023 Downstream channel.

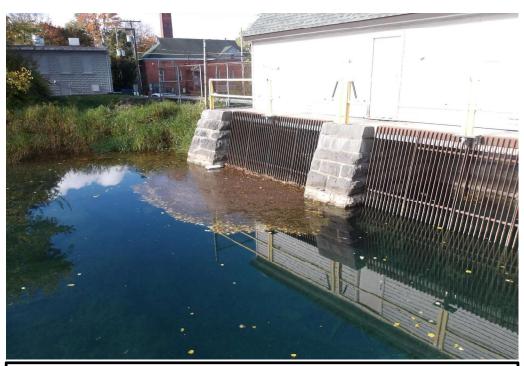
The inspection revealed overgrown wetland vegetation (cattails and phragmites) growing on the upstream side of the spillway in the approach area, on the downstream side of overflow section of bulkhead structure below the gate house on the right embankment, and between the stone blocks on left side of bulkhead structure.

Photo 6 Dam ID# 073-0355 Skaneateles Lake Dam 10/23/2023 Service spillway obscured by vegetation at the left end of the dam.

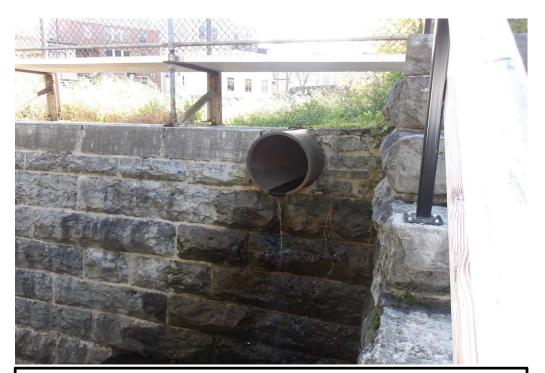
Photo 7 Dam ID# 073-0355 Skaneateles Lake Dam 10/23/2023 Left downstream groin with pipe observed leaking.

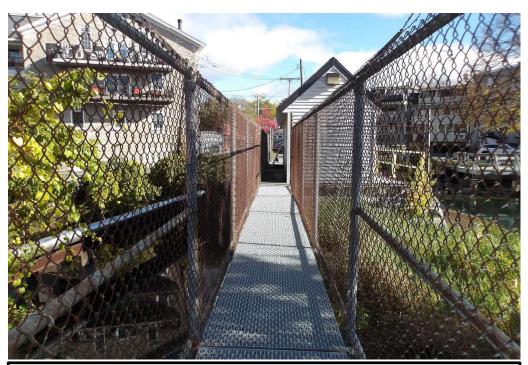
Photo 8 Dam ID# 073-0355 Skaneateles Lake Dam 10/23/2023 Walkway on the left end of the dam, over a spillway.

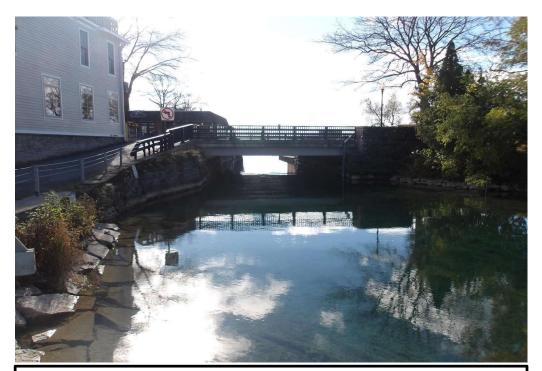
Photo 9 Dam ID# 073-0355 Skaneateles Lake Dam 10/23/2023 Approach channel to the dam, looking upstream.

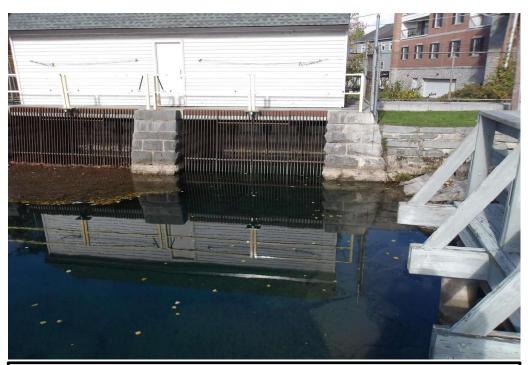
Photo 10 Dam ID# 073-0355 Skaneateles Lake Dam 10/23/2023 Right upstream face of the dam.
